## **BUILDING REPORT**

June 21, 2011

RE: 810 North Main Street - Evaluation

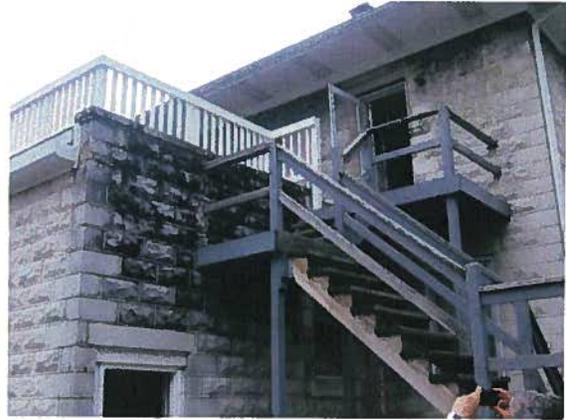
**West Stair**

The subject building has had severe alterations to one primary facade (east) and the interiors. The condition of the building envelope has not been well maintained and will require cleaning and repair. The conveyance systems (stairs and elevator) will need to be replaced or newly installed.

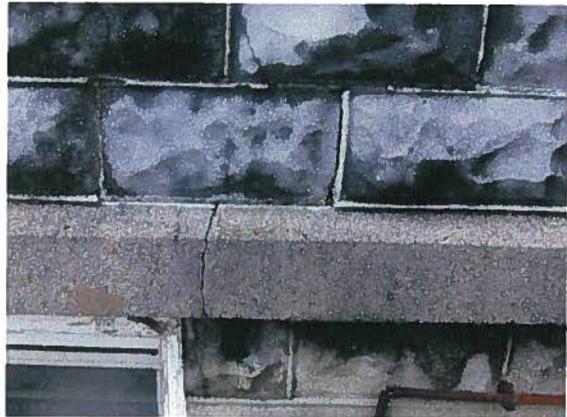
**Masonry Detail 1**

While in general the condition of the exterior masonry is good to fair, there are several areas where distress or deterioration of the concrete needs repair or replacement. In addition, there are several areas (especially on the north facade) where the porous concrete has become discolored and needs cleaning and repair. The installation of utility lines, especially on the north facade, has severely compromised the appearance of the RCB facade – a more sensitive utility installation would help the visual appearance of the building

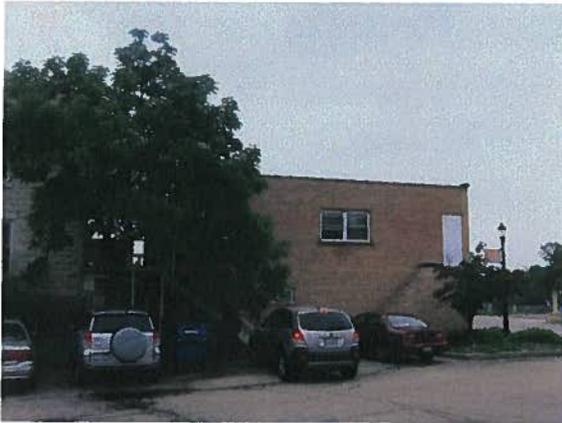
**Connected Building to East**

The proportion of openings on the facade reflects the internal needs of the building rather than a measured symmetry and proportional arrangement of balanced facade openings. In addition, the connection with the multi-story commercial building to the east has severely altered the eastern facade of the subject building.

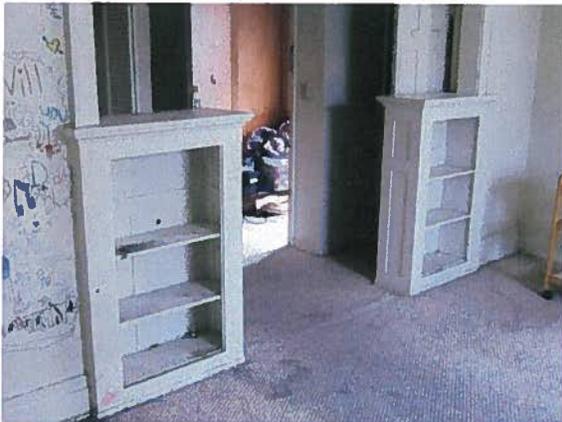
**Interior Millwork**

Where the exterior of 8NM has been relatively well preserved, the interior has been dramatically altered from its original design. Only on the third floor are the majority of original wood trim, floor, and doors still in place. The basement and first floor have recently installed kitchens, bathrooms, and trim details that have removed most of the original architectural details.

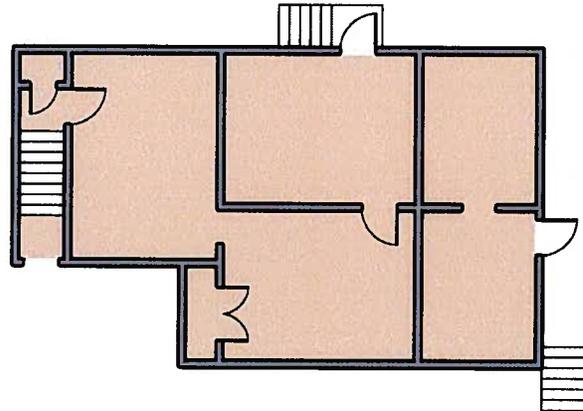
Lower Level

Most of the area of the lower level is below the minimum code allowed ceiling height and without major alteration, could only be used for mechanical space or storage.
